# Development of a risk assessment tool to assess the significance of septic tanks around freshwater SSSIs

Phase 1 – Understanding better the retention of phosphorus in the drainage field

First published 03 February 2015

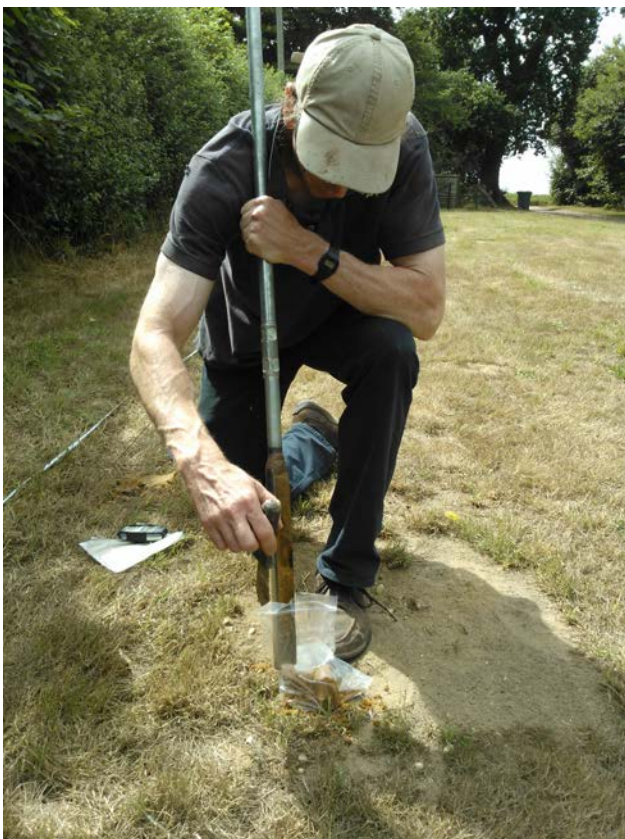
**Plate 1** Soil coring with an auger

Soil cores, approximately 0.3 m in length, were collected with a standard auger (Plate 1) at approximately 0.5 m depth intervals, where possible, across the drainage field (Figure 1). These samples were collected to provide information on changing soil P status and porewater P concentrations with depth and distance from the source. In many cases, sampling and subsampling strategies had to be modified to take account of local site conditions, such as soil structure and the depth of the underlying bedrock material. At the Hampshire sites, it was not possible to take samples close to the tanks as these were situated in inaccessible private gardens.

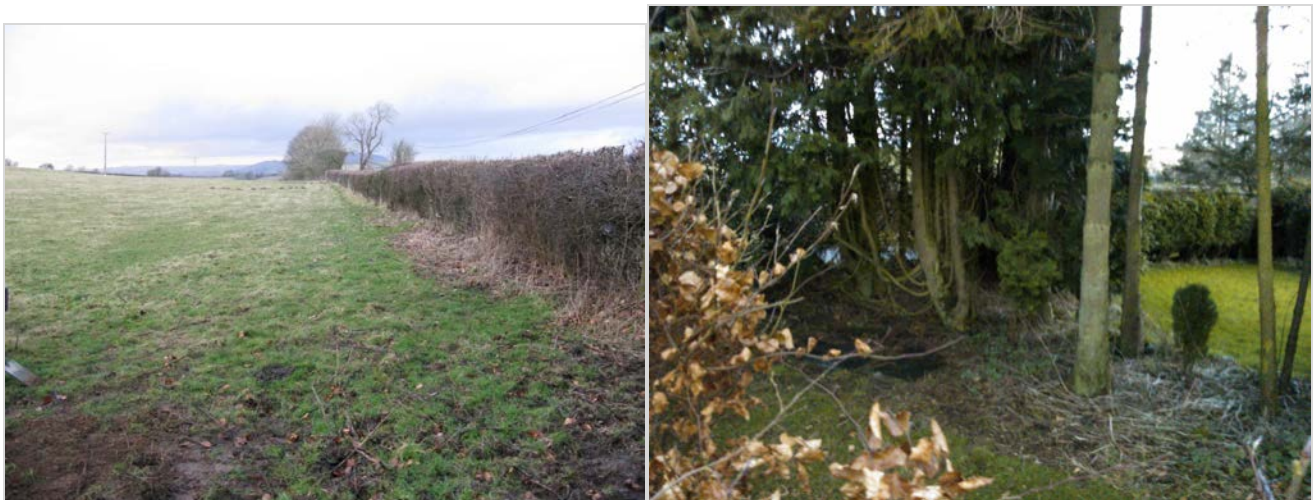
**Plate 2** Septic tank location (left) and drainage field (right) at site CLUN1

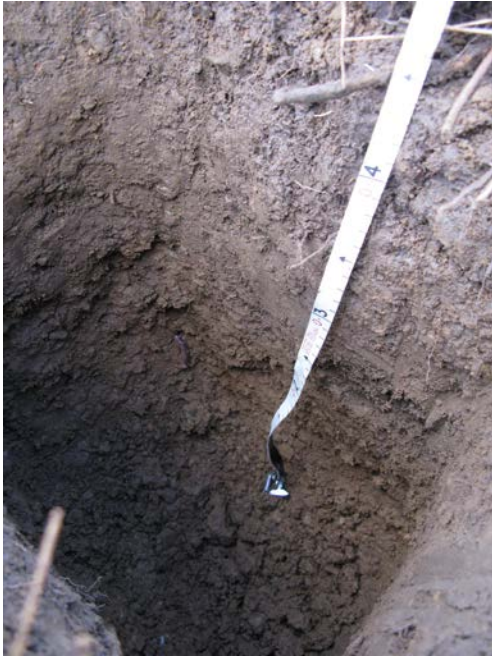
**Plate 3** Soil profile within the drainage field at site CLUN1

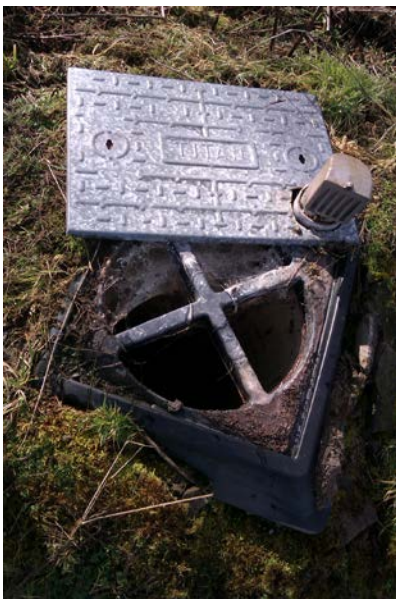
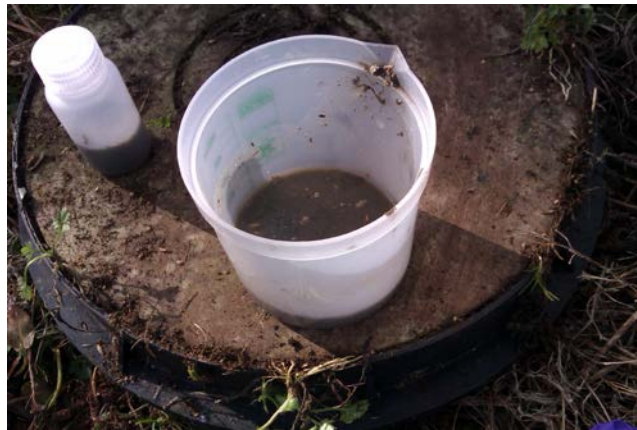
**Plate 4** Septic tank access point and sludge collected from the storage tank at CLUN2

The septic tank serves holiday accommodation with seasonally varying occupancy and, at times, remains unused for long periods. It was readily accessible (Plate 4, left) but, at the time of sampling, the effluent was covered by a very hard surface crust. Although this was broken using soil augers, the volume of liquid effluent below the crust was small and was grossly contaminated by the solid crust material (Plate 4, right). So, no representative sample of the effluent plume could be collected at this site.

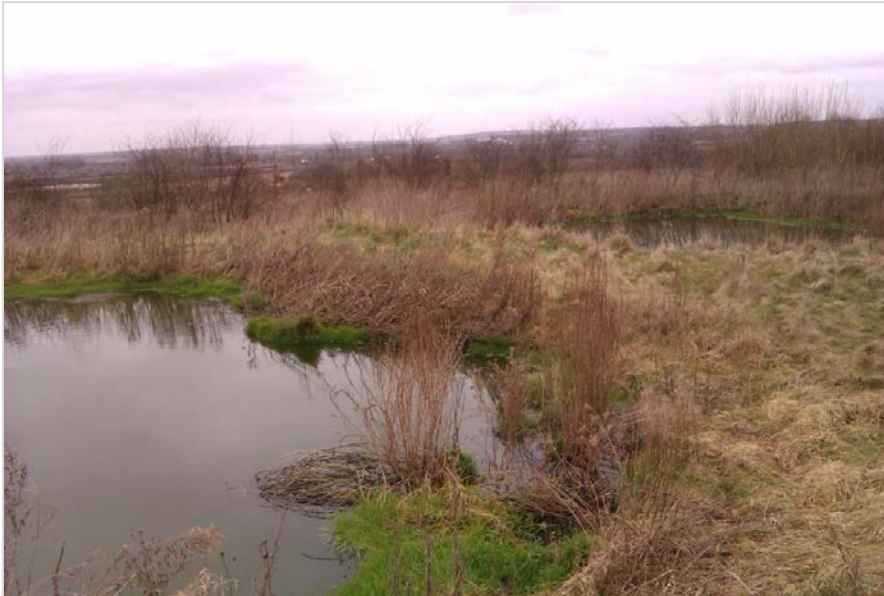
**Plate 7** Effluent processing pond at OXON1

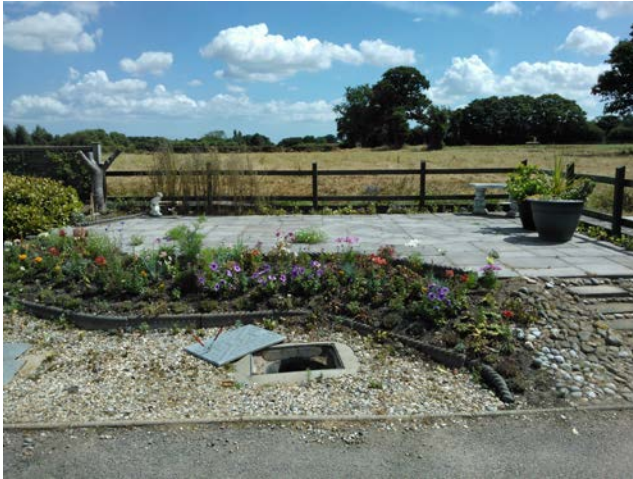
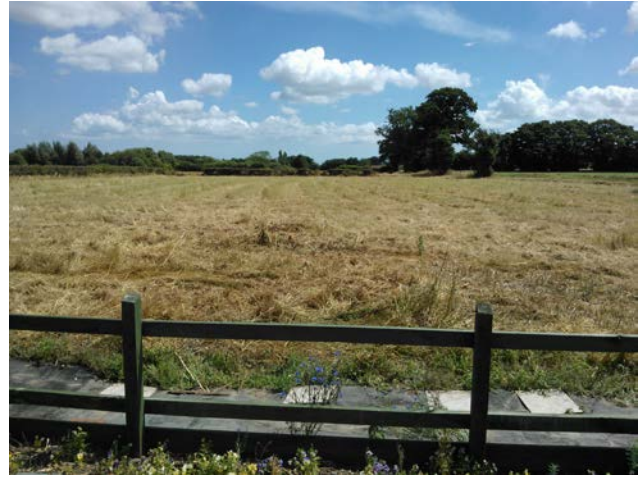
**Plate 10** Septic tank (left) and drainage field (right) at BROADS1

The tank itself was accessible for sampling (Plate 10: left) and the owner believed that the seepage area (Plate 10: right) could be identified by the patches of nettles growing nearby. It was possible to position the sampling directly over the perceived seepage area. There was no obvious slope to the ground in this area; the elevation data collected suggested that the slope was about 2%.
