# The impacts of tracks on the integrity and hydrological function of blanket peat (NEERoo2)

1st Edition - May 2013

Natural England Evidence Review NEER002

# The impacts of tracks on the integrity and hydrological function of blanket peat

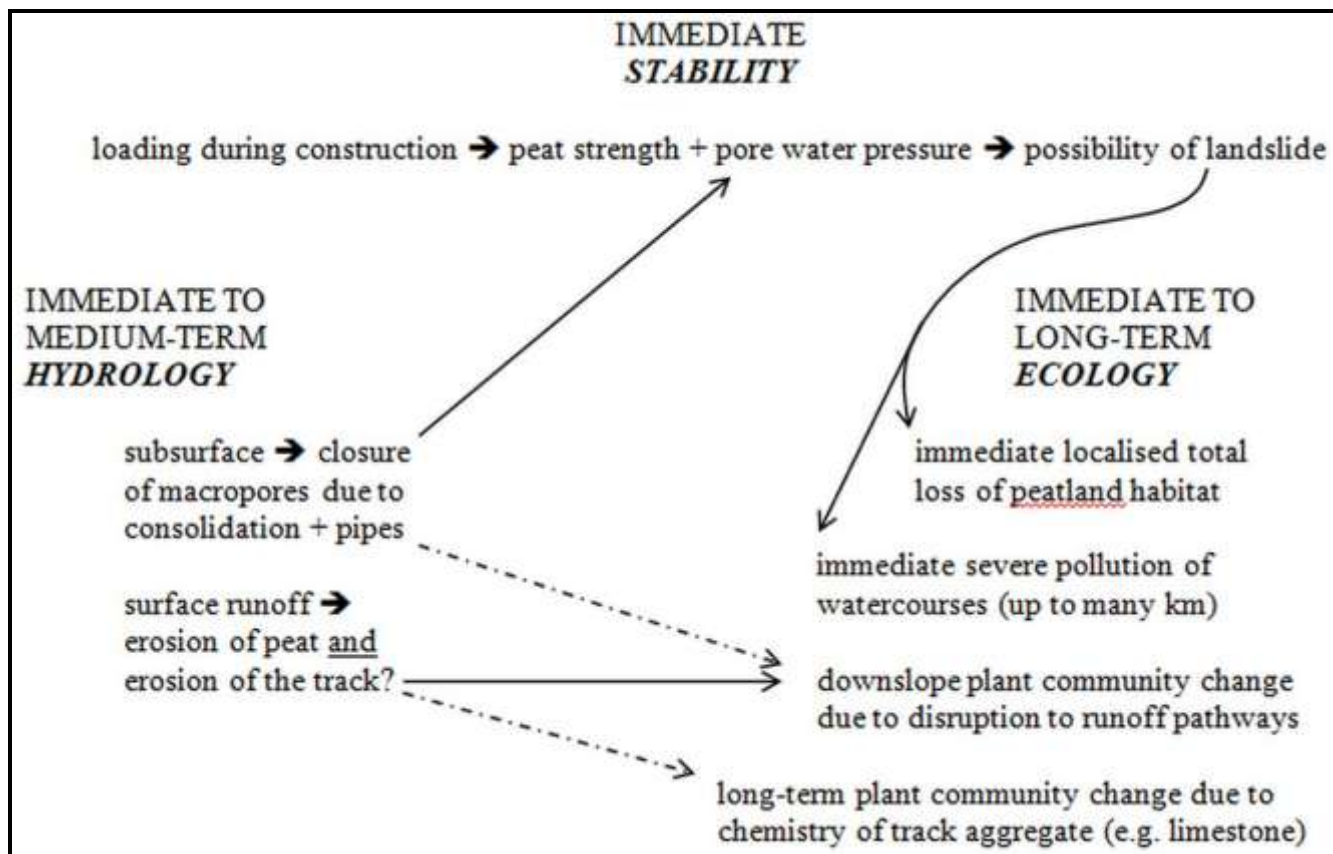
(Diagram: A P Dykes). Solid long arrow = major effect of one impact on another; dashed long arrow = minor effect; arrows indicate the direction of influence.

**Figure 1** Conceptual framework for understanding the linkages between different impacts of track construction

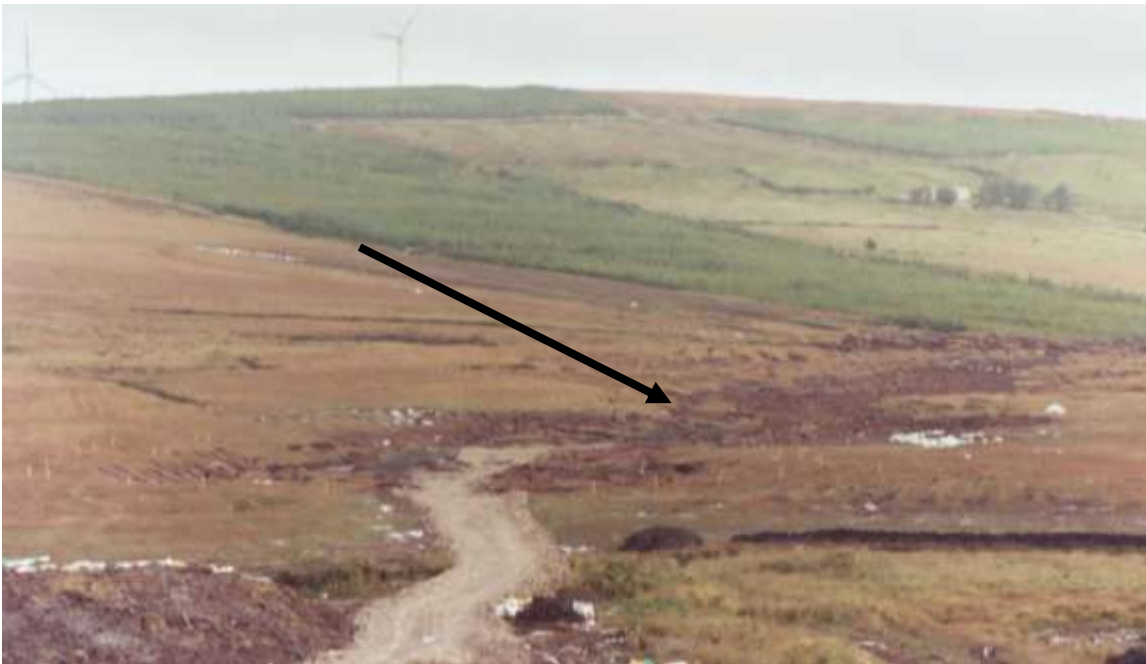
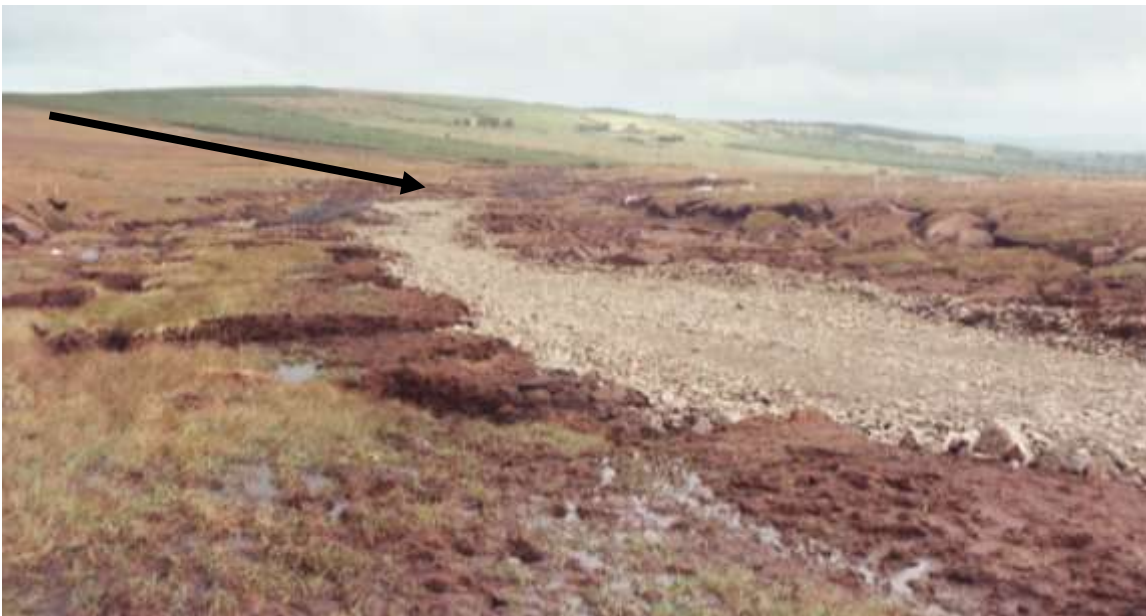
**Figures 2 and 3** On 22 August 2008, work to construct a 'floating road' on 3 m deep blanket peat, to provide access for a new wind farm on Ballincollig Hill, Co. Kerry, Republic of Ireland, triggered a 130,000 m<sup>3</sup> landslide (see paragraph 3.30 for evidence statement). Peat-cutting activities 10 years earlier constituted a contributory factor in this event. The photos show the site after about 100 m of destroyed road had been rebuilt into the landslide area in order to facilitate recovery of the construction plant

- 3.30 One study (2++) investigating the causes of 9 peat slope failures in August 2008 in Ireland found that suspected trigger for one failure was the construction of a track (Dykes & Jennings, 2011; see Figures 2 and 3). Following a 'discussion' on this paper in the journal of publication, Dykes & Jennings made the further observation in their reply that the cutting through of the peat to a depth of 1-1.5 metres as part of the process for extracting peat 'turves' destroyed

the tensile strength of the peat at the site in question, thereby contributing to the occurrence of the slope failure when loaded by the construction work (Long *et al.*, 2011).

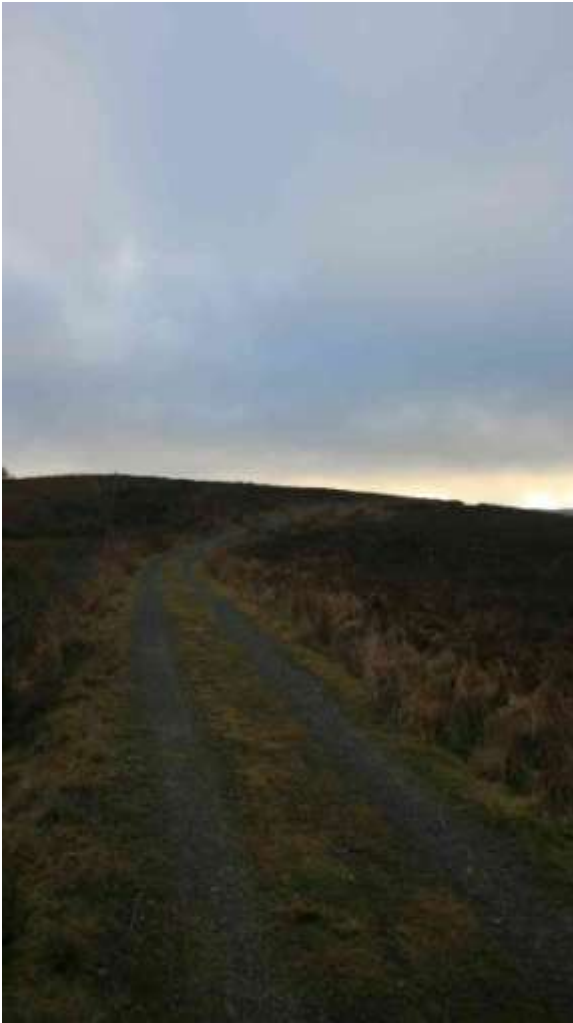
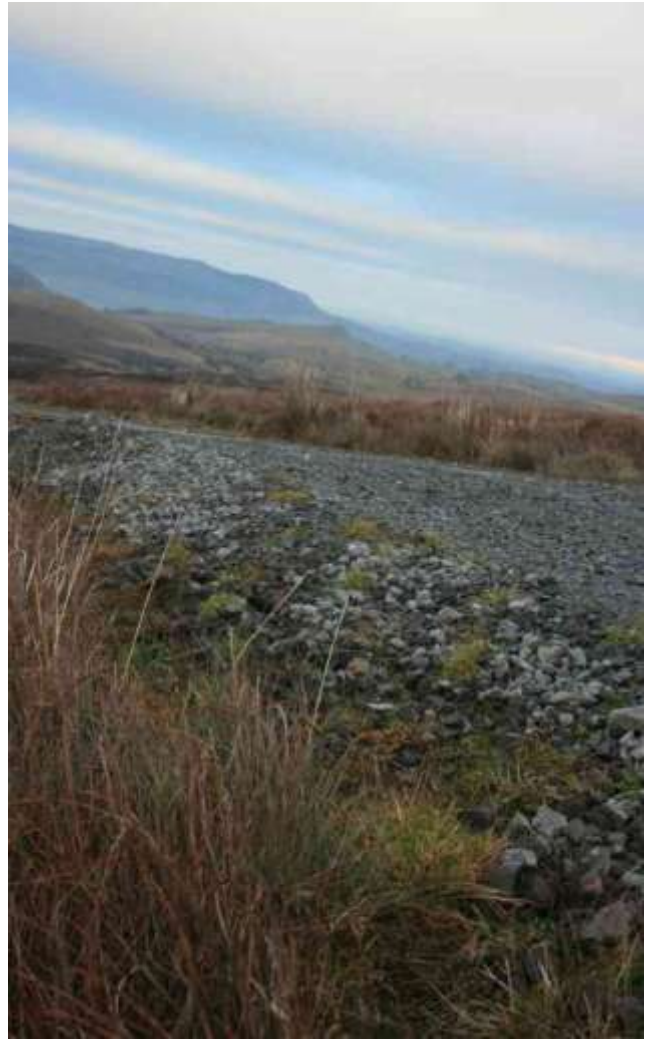
**Figures 4 and 5** This small, non-mettalled 'floating road' was built in around 1998 across blanket peat in the Cuilcagh Mountain Park, Co. Fermanagh, Northern Ireland. Although largely successful in terms of its purpose and design (in allowing vehicle access), evidence statement 3.43 in part refers to this example.

- 3) Most of the failures of the track were in the degraded cut-over bog and required considerable depths of stone to build the track, in some cases 1.3 metres rather than the design depth of 0.3 metres.

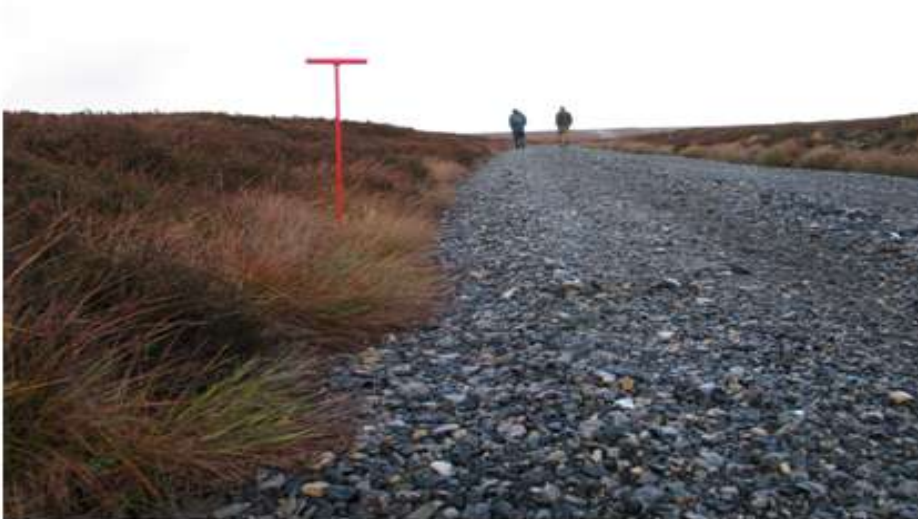
**Figure 6** When this photograph was taken in the North Pennines, the track was about ten years old and this corner had been built up at least once. At the time of construction this track was above the surrounding bog

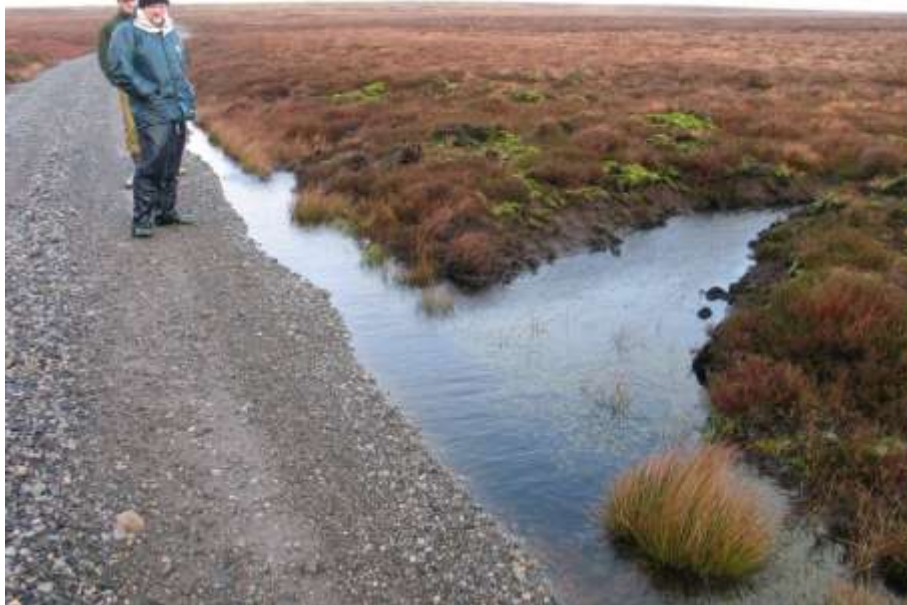
**Figure 7** Ponding of water by the side of a moorland track in the North Pennines. Note the drainage channel intended to remove the surface water

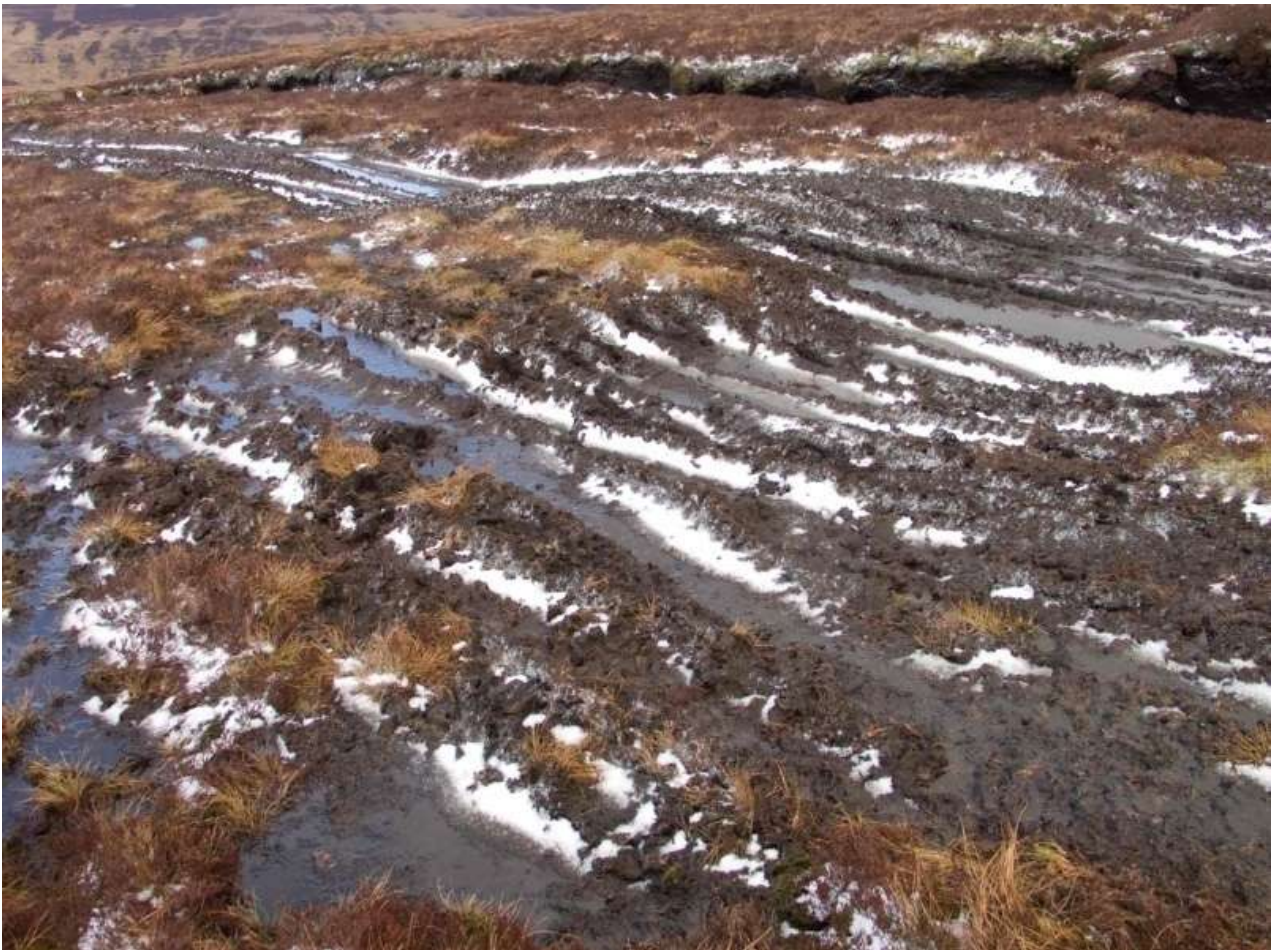
**Figure 8** An example of track widening (braiding) in the North Pennines. The vehicle used in this example was hagglund which is a tracked vehicle (Gross vehicle weight 4,800 kg, ground pressure 140 k Pa (0.14 kp/cm<sup>2</sup>))

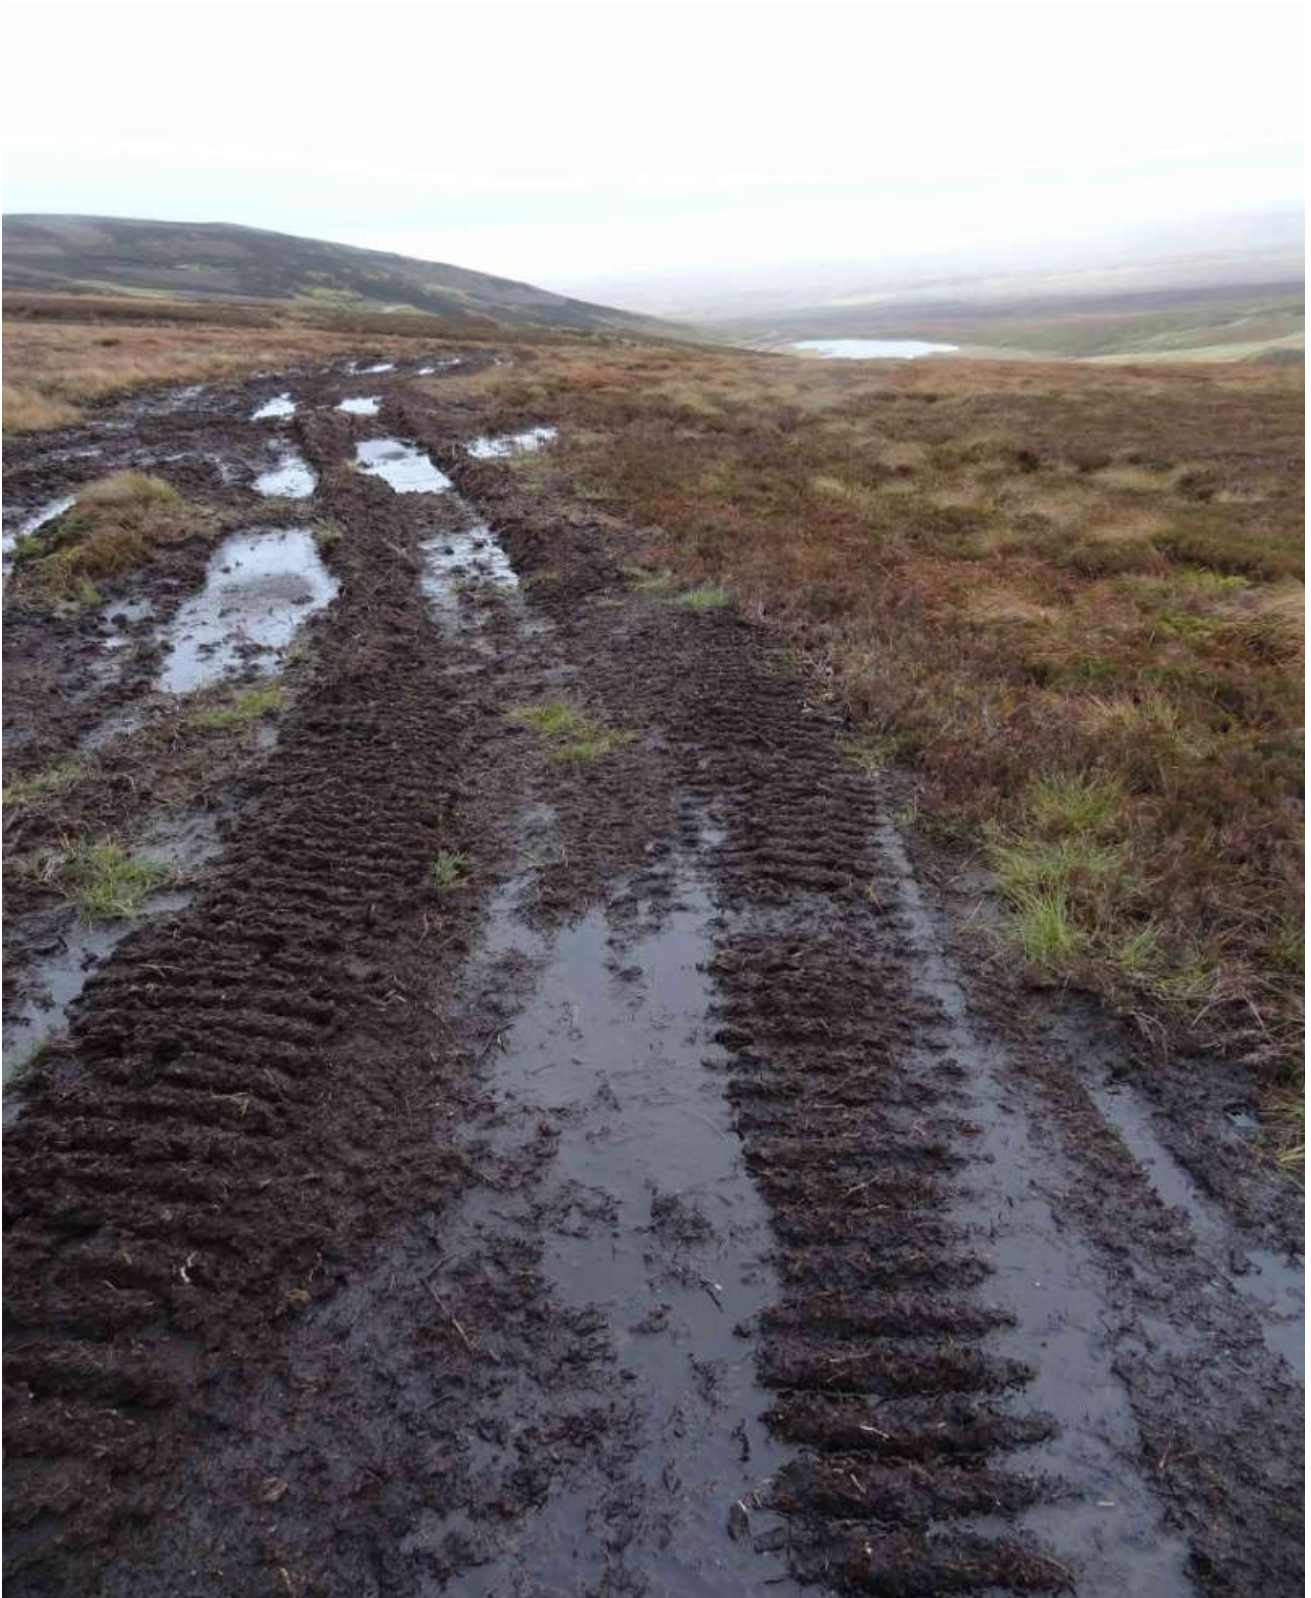
**Figure 9** Damage caused by a hagglund in the North Pennines

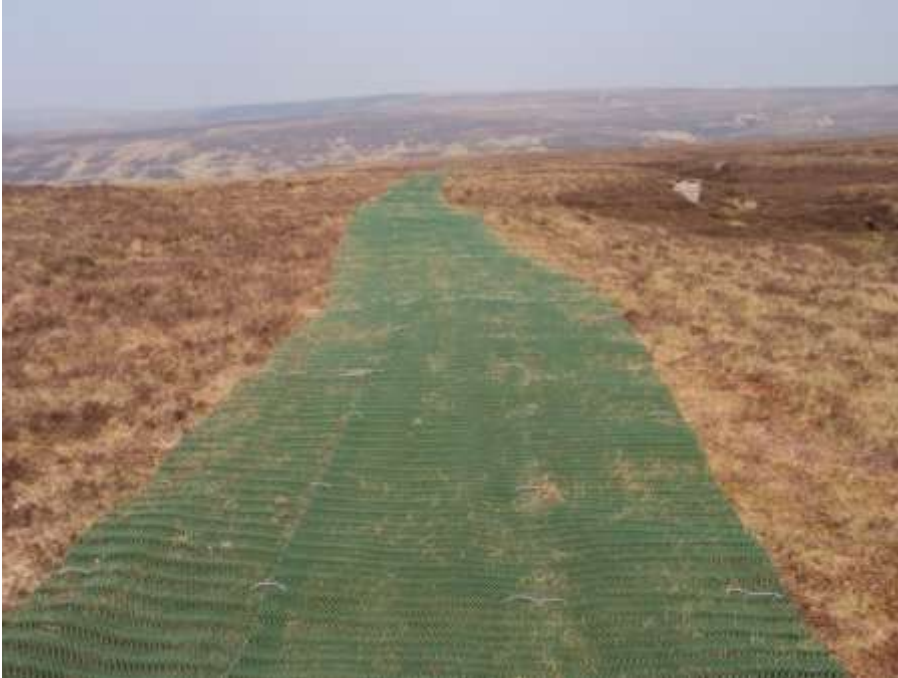
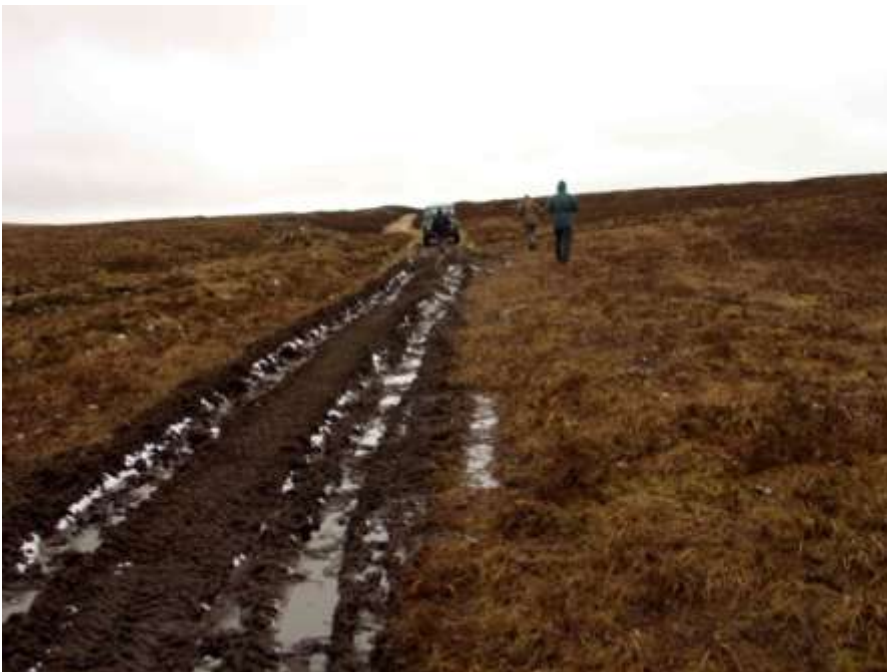
**Figure 10** Above: A mesh track surface in the North Pennines. Below: The same track prior to putting the mesh surface in place

7.8 A recent development for vehicle use is an artificial membrane that is laid over the surface of the ground (for example, Figure 10). The use of this material on blanket bog is currently the subject of a research studentship based at Moor House National Nature Reserve and a neighbouring site and is due to report in 2015. This type of material may provide an important alternative to allowing access without the damage associated with unmade tracks, the hard engineering required for constructed tracks or indeed a hybrid solution where membranes might be used to reinforce sections of an unmade track, thus minimising the amount of work and cost associated with forming a track.

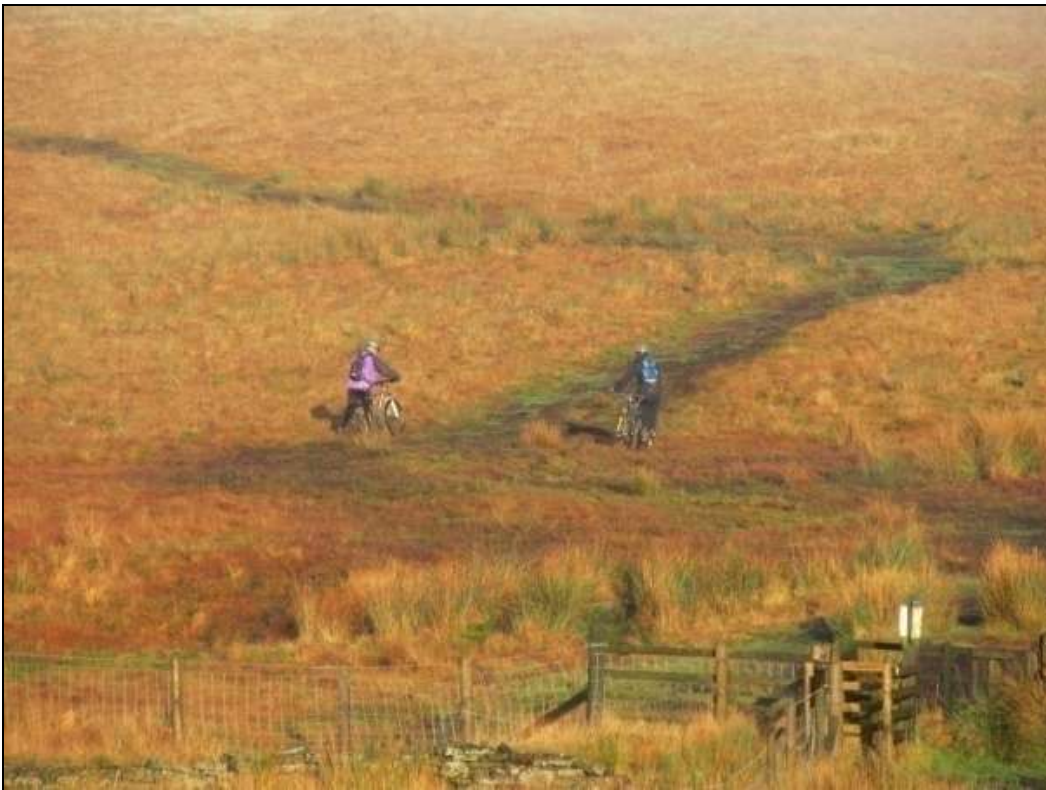
**Plate A** Mountain bike and foot path damage in the West Pennines. Photo: United Utilities.

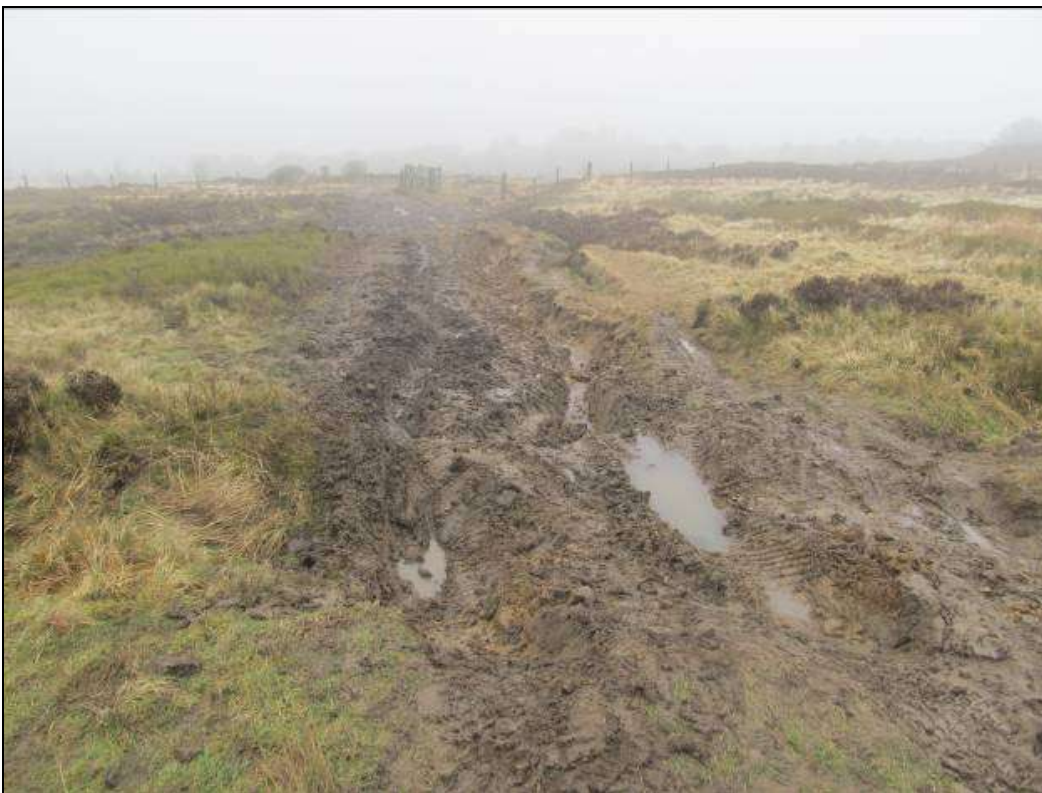
**Plate B** Vehicle damage in the West Pennines. Photo: United Utilities.

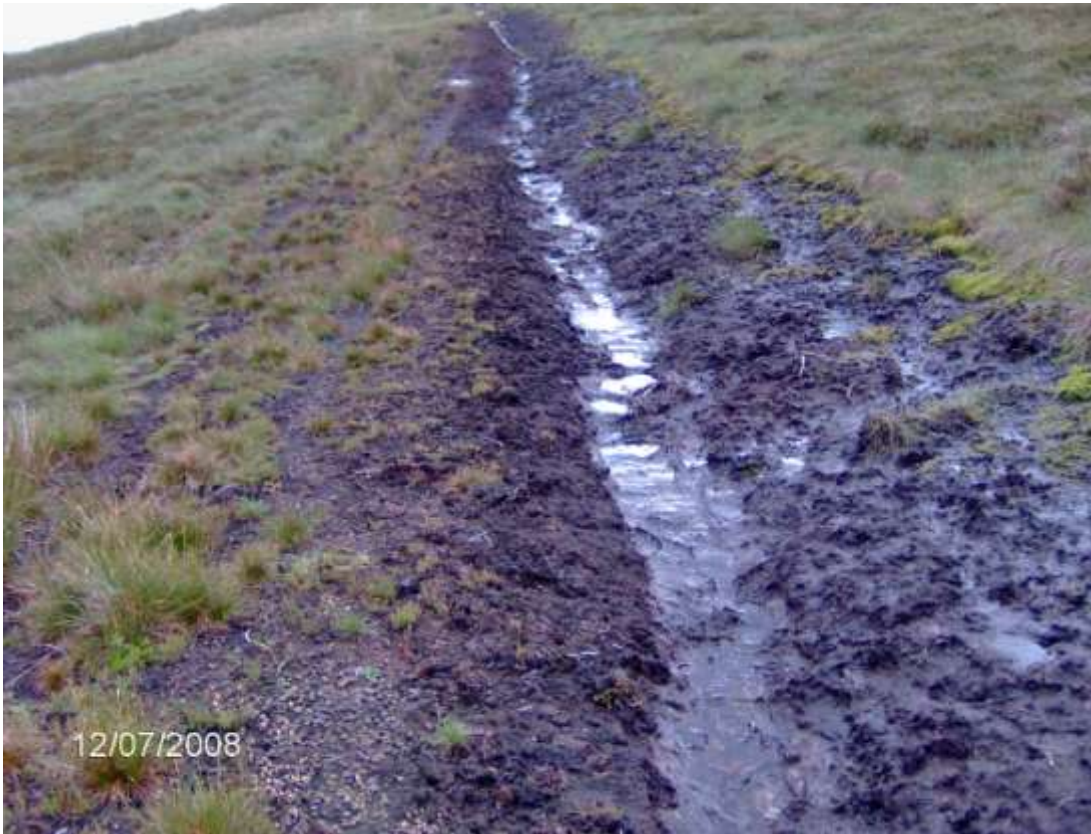
**Plate C** An example of track damage submitted to the Uplands Evidence Review. Photo: A. Peart, 2008.

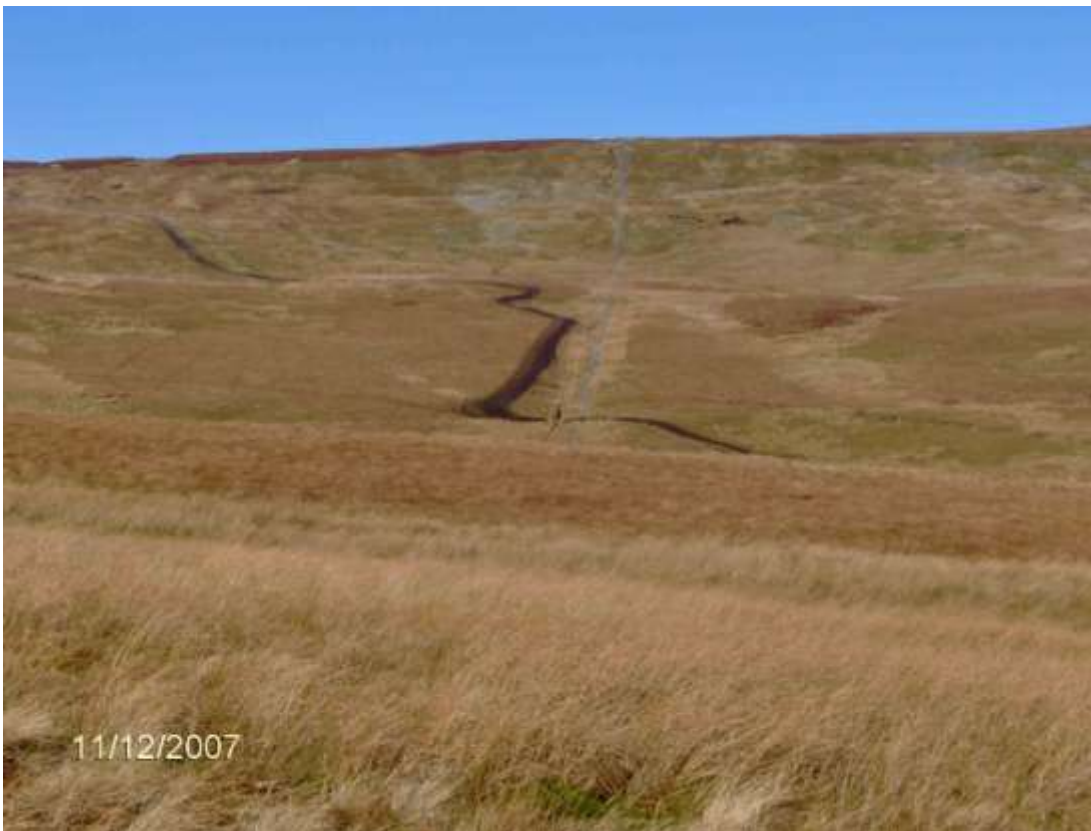
**Plate D** An example of track damage submitted to the Uplands Evidence Review. Photo: A. Peart, 2007.
